# NEWSLETTER

## WATER INGRESS MITIGATION AND RESTORATION

**In this issue of the Newsletter, we review a water damage Restoration claim involving a town house in the inner city of Sydney.**

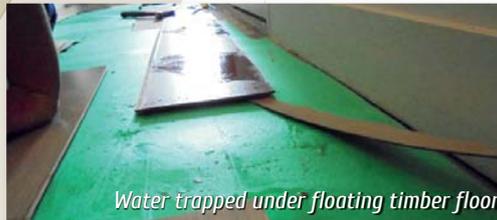
A home in Sydney's inner city suffered significant damage as a result of a flash flood, following typical Sydney storm activity. The flood occurred because the storm water drains in the multi dwelling complex could not cope with the large volume of water that was deposited by the storm. Fortunately the owners of the home are fully insured and were able to call their Insurer for assistance. A national Restoration management company was appointed to organise a restoration company to attend the claim. ADR was engaged to provide urgent mitigation and Restoration services and quickly despatched a team of experienced Operators to the inner city location. Once on site, the ADR staff began by performing the requisite introduction and risk assessment. ADR's Operators are trained to identify and neutralise any potential dangers that may occur when attending water ingress claims and they understand the importance of ensuring their work environment is free from hazards. The staff lifted furniture and other contents to relieve them from the standing water and then proceeded to extract the residual water, also positioning drying equipment throughout the home to reduce moisture levels.

*Water trapped under floating timber floor*

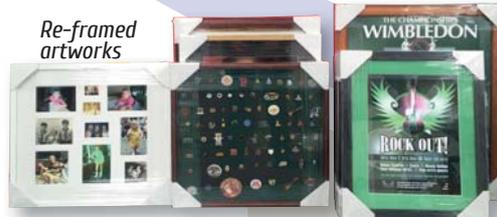
*Re-framed artworks*

Included in the contents were a number of framed artworks which held significant sentimental value to the Insured. These fragile pieces were delicately dismantled, dried and re-framed, as specifically instructed. There were more than 25 electronic/electrical items included in the affected contents, requiring inspection and/or Restoration. The ADR Technicians were able to decontaminate, test and ultimately Restore approximately 90% of the electrical items at considerably less cost than replacement, excluding low value items such as power boards etc., which are considered uneconomical to Restore.

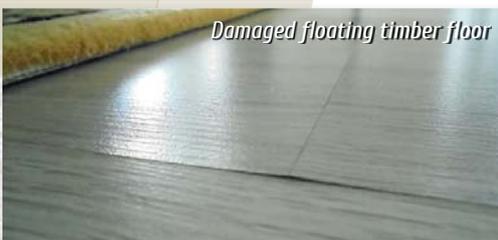
*Damaged floating timber floor*

Parts of the home were covered by floating timber floor boards which were immediately starting to pop and warp following the ingress. With water also trapped underneath them, the possibility of drying the concrete slab below was very low, therefore the floating floors were removed in order to improve the drying equipments efficacy.
